ERRATA NOTE

CC1100E

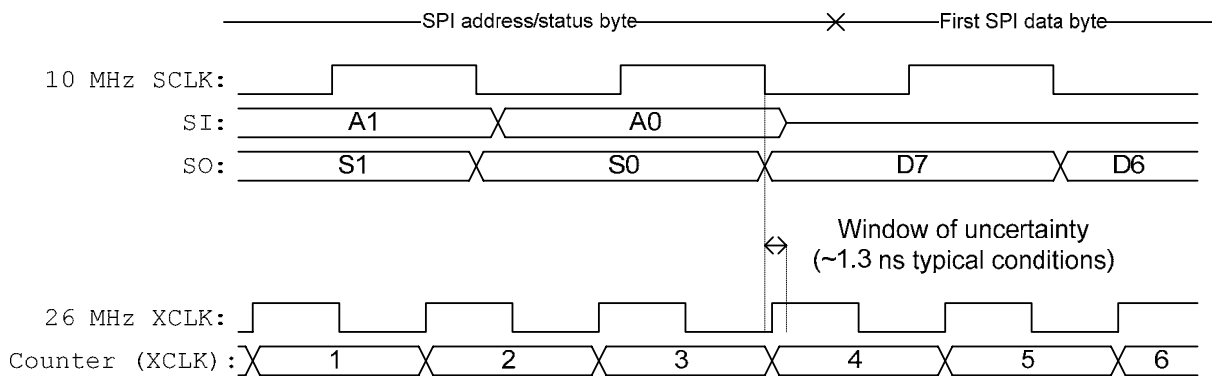
Figure 1: Window of Uncertainty (drawing not to scale)

Due to this synchronization issue, if the register being read changes value (synchronously with XCLK) during a certain period of time after this falling edge of SCLK then some of the bits in the read value will come from the **previous** value and some from the **next** value. This so-called window of uncertainty is about 1.3 ns for typical conditions and increases to about 2.0 ns for worst-case conditions (1.8 V VDD, 85 °C).

Figure 1 shows a timing diagram of an SPI read that fails when reading a fictitious counter being updated internally each **XCLK**. Since the counter update from value **3** (011b) to **4** (100b) within the window of uncertainty, the read value could be any one of 0-7 (000b, 001b, 010b, 011b, 100b, 101b, 110b, 111b) depending on exactly when the positive edge of **XCLK** falls within the window of uncertainty.

If it is important to **ensure** that read values are not corrupted, reading of one of the affected registers should be done repeatedly until the same value is read twice in succession. If the rate at which the register is read is specified to be at least twice as fast as the expected register update rate, then an upper bound on the number of required reads is four and the average number of reads slightly more than two.
