ICM D Customer Care Information from Dec. 6st, 2000 – limited distribution to the affected countries -

Subject: faulty capacitors on Gigaset 3010 ratio

Gigaset 3010 ratio base station (state > 50 (figure after the last dash in the part-no.)) Gigaset 3010 Micro base station

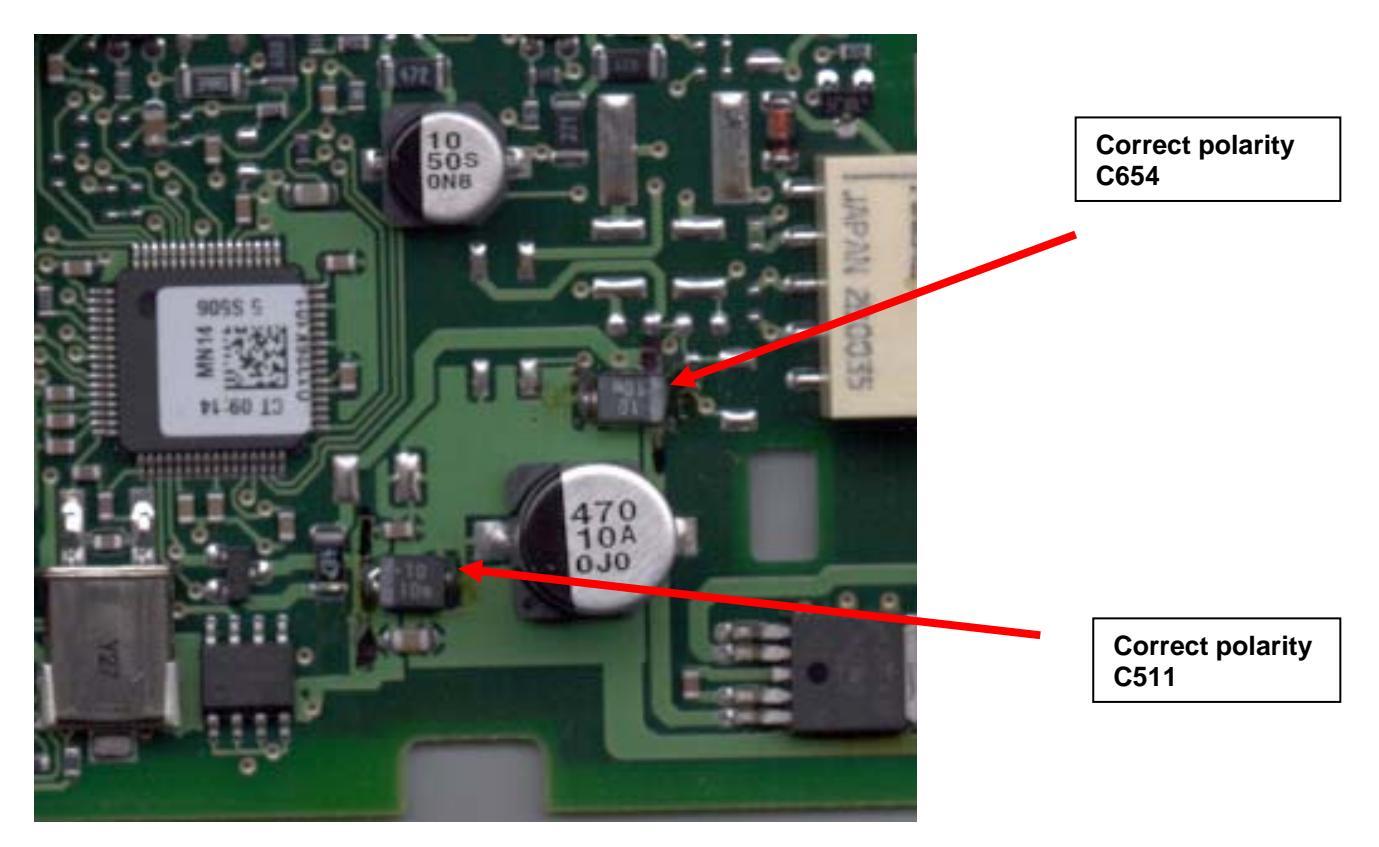
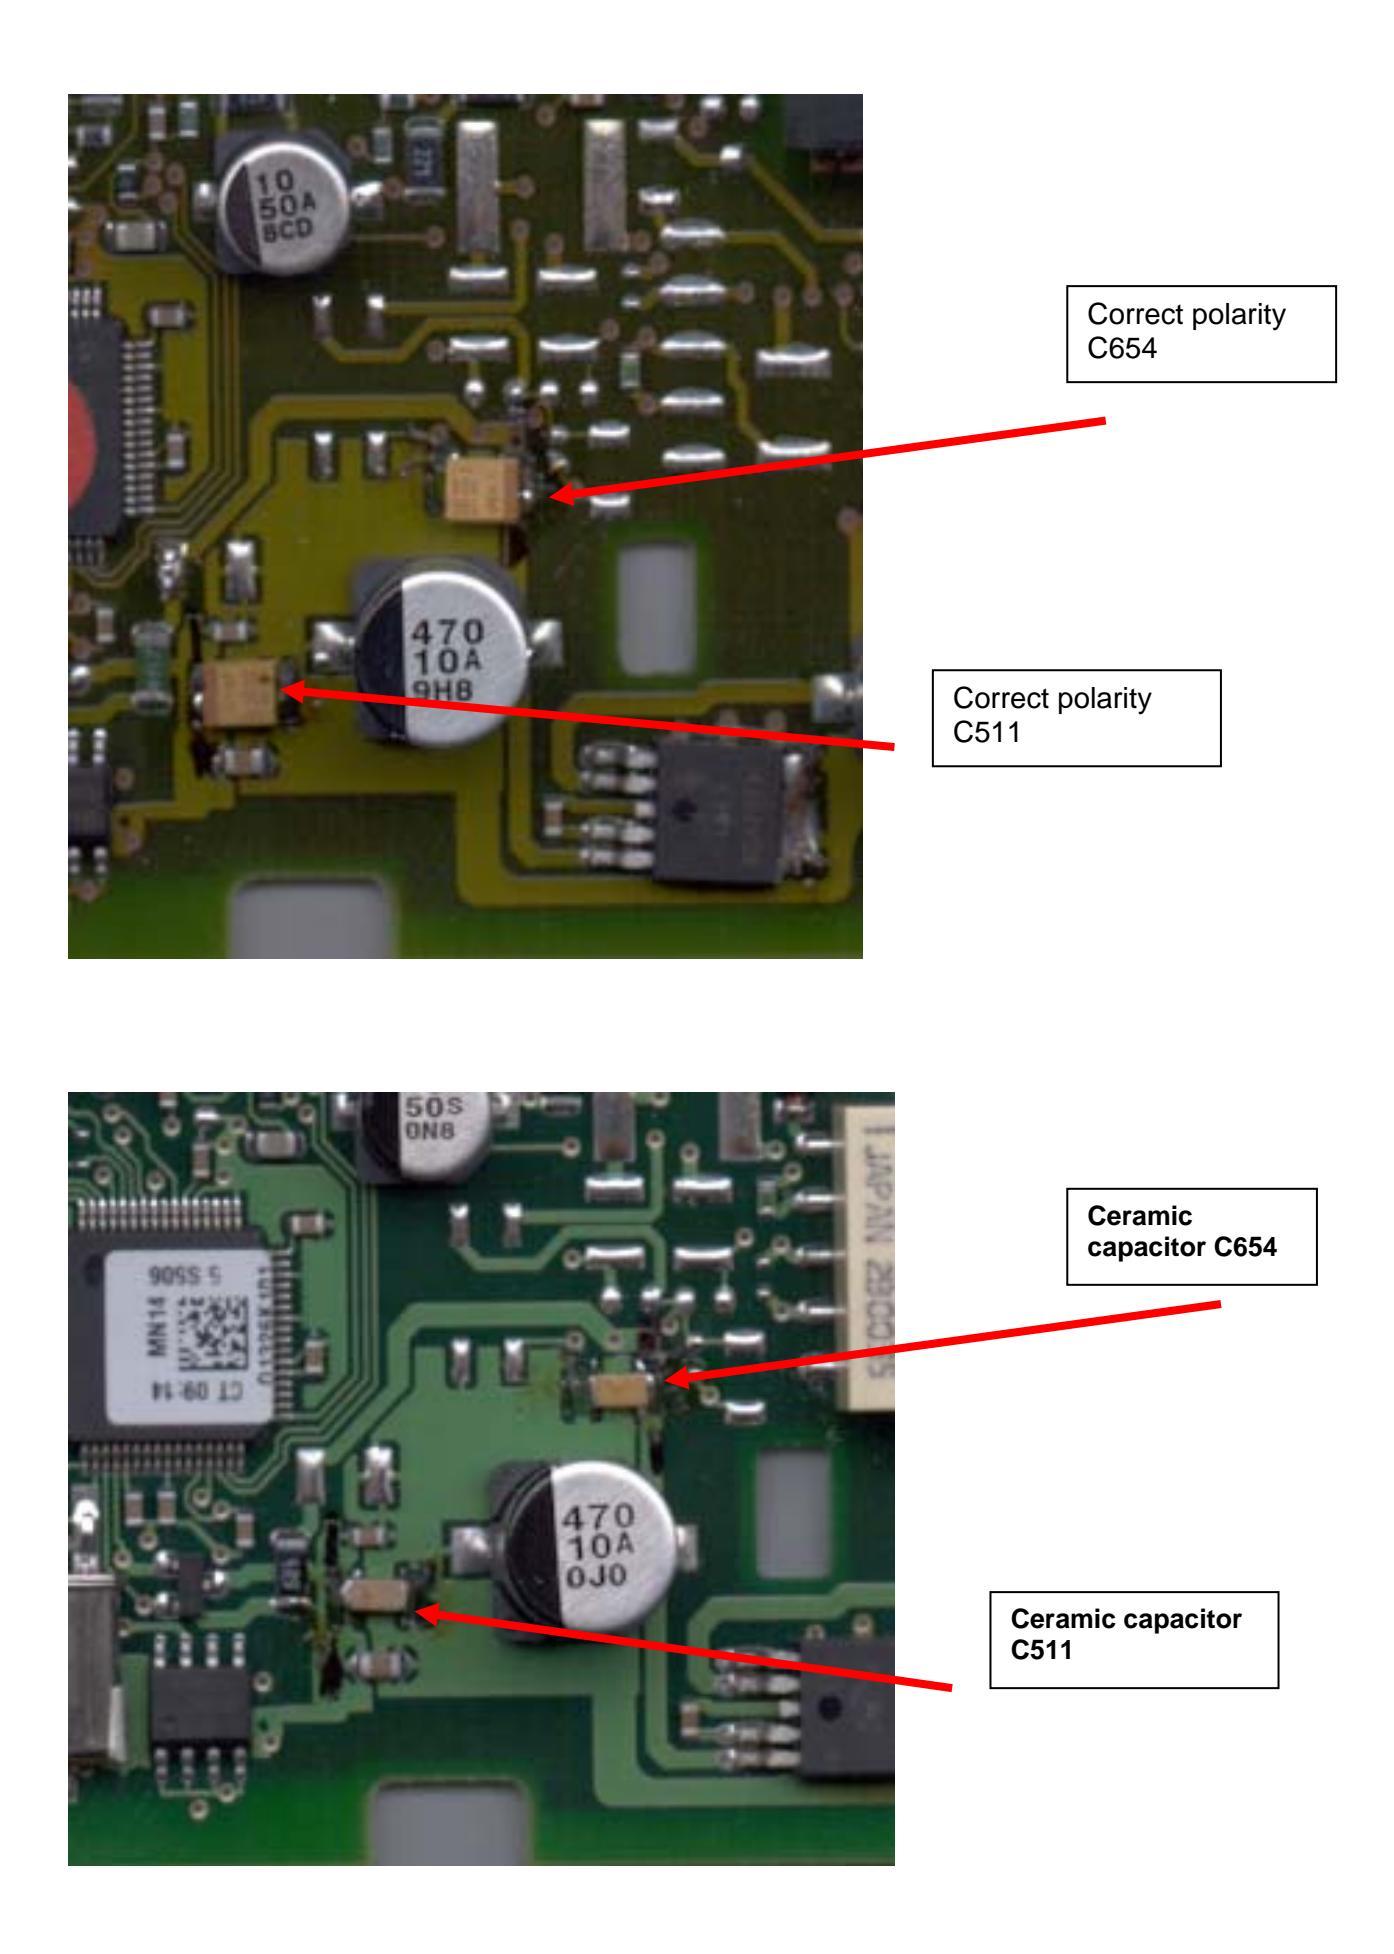
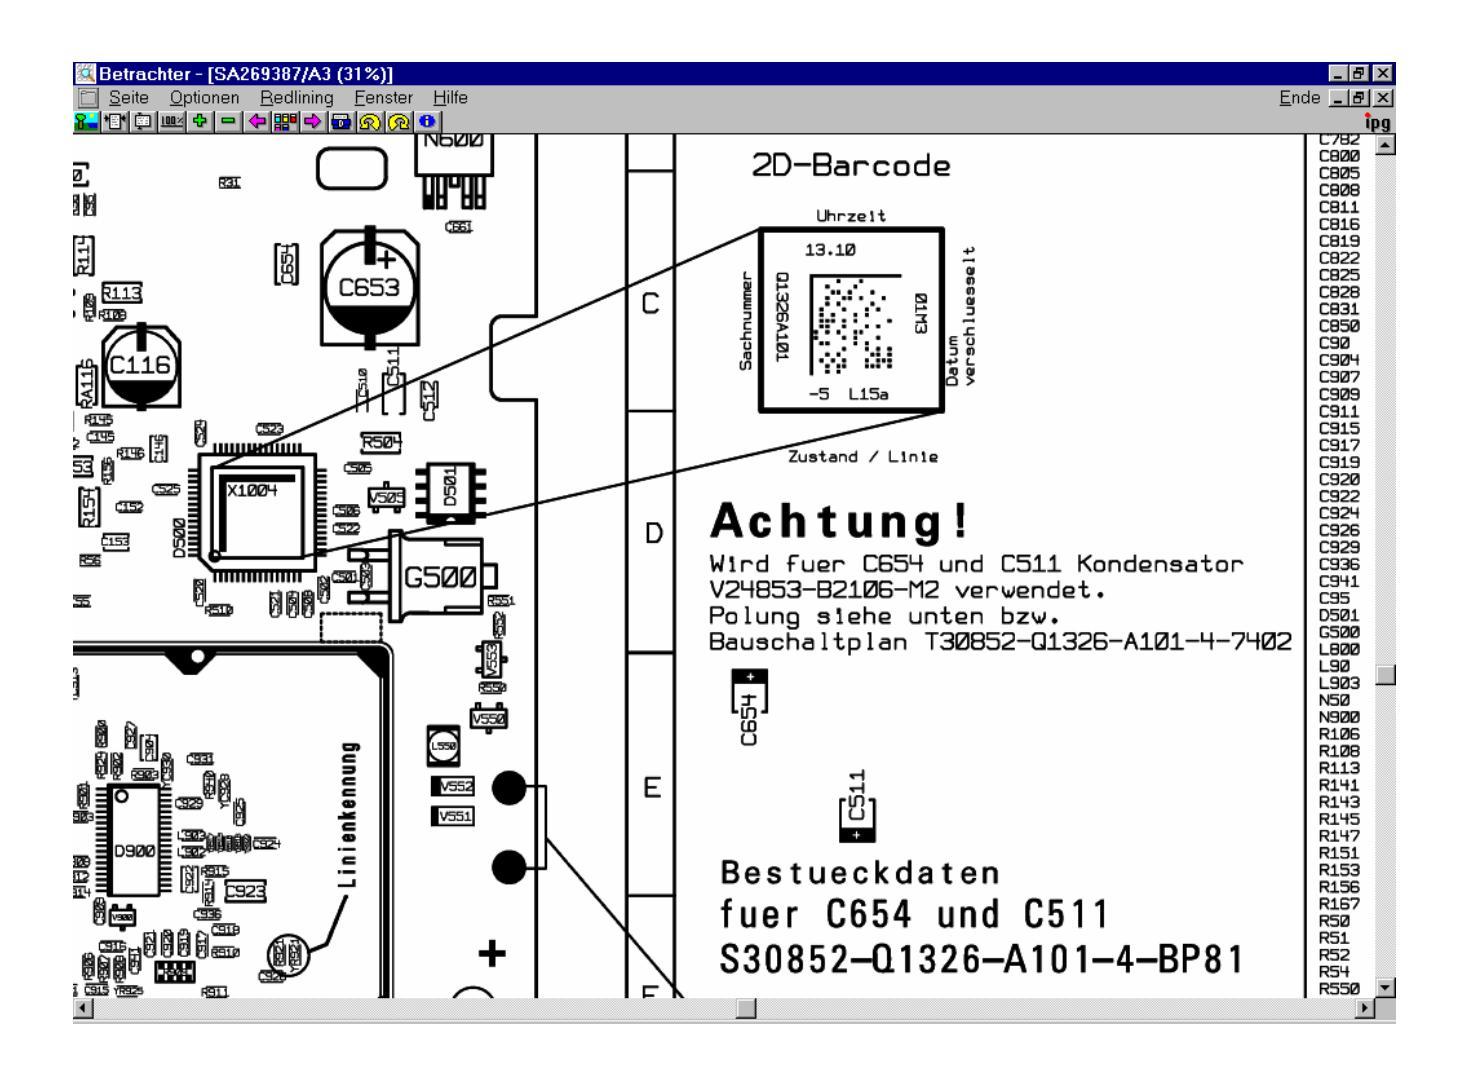
The boards of the affected base stations have been equipped with Tantal capacitors with wrong polarity (C511, C654). After a short time of usage the capacitors short-'circuit and cause a breakdown in the voltage.

The plus pole of the Tantal capacitors is marked with a line.

See pictures below for correct soldered Tantal capacitors and different types of capacitors (yellow (brown line=plus pole) and black (silver line=plus pole)Tantal capacitors)

Every affected new base station (from the stales stock) has to be repaired by desoldering the capacitors turning them for 180° and resoldering them. If the base station has been manufactured with **ceramic capacitors** 2. Photo below) there is **no need of replacement**.

Regarding devices that have been returned from the customer the capacitors must be replaced by new ones (see right polarity on the photos below).
